Pompeii's Stabian Baths. Mechanical behaviour assessment of selected masonry structures during the 1st century seismic events

Ruggieri Nicola⁽¹⁾, Galassi Stefano^{(2)(*)}, Tempesta Giacomo⁽²⁾

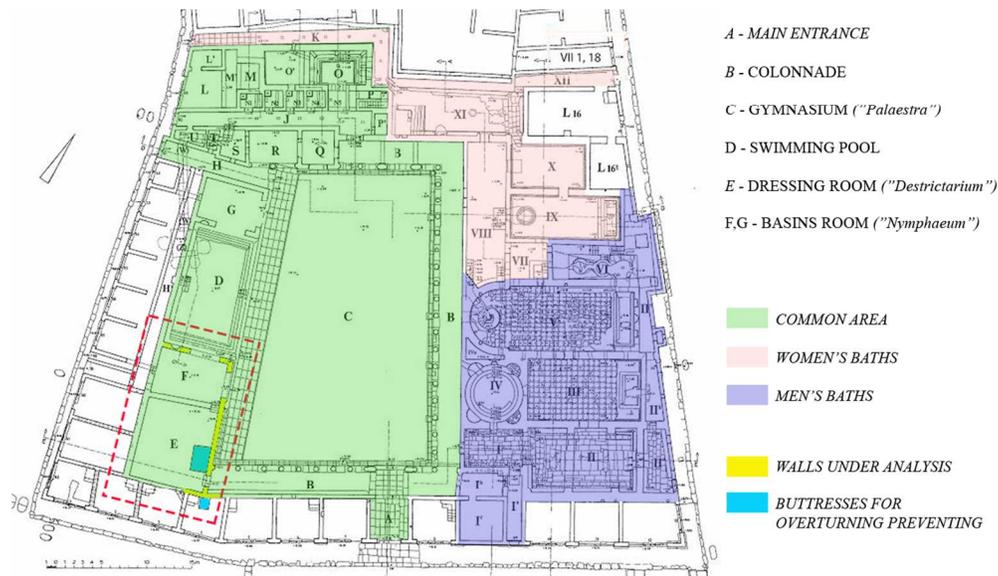
Fig. 1. Stabian Baths site plan. Elaboration of Hans Eschebach (1979) original drawing to distinguish the women's baths from the men's baths as well as the common area and to highlight the use of the main blocks which have been structurally modelled. The destrictarium masonry wall damaged by AD 62 earthquake is also indicated together with the strengthening interventions carried out consequently

23
24 The central core of the baths (Fig. 1), in its current configuration, is formed by a
25
26 trapezoidal *palaestra* which laterally provides access to the women’s and men’s baths,
27
28 divided by a common *praefurnum*, composed of three *caldaria* (i.e. boilers). The two male
29
30 and female sectors are composed of the *apodyterium*, the room where bathers could
31
32 undress, *frigidarium*, *tepidarium* and *calidarium*. The *calidarium* is facing south-east
33
34 according to Vitruvius’ suggestions. It is very interesting the presence of the *Hypocaustum*,
35
36 still in situ and clearly visible, where the technical recommendations proposed by the
37
38 architect of August, are perfectly observed so as to award to the Pompeii’s Stabian Baths
39
40 also an exceptional educational value.
41
42
43

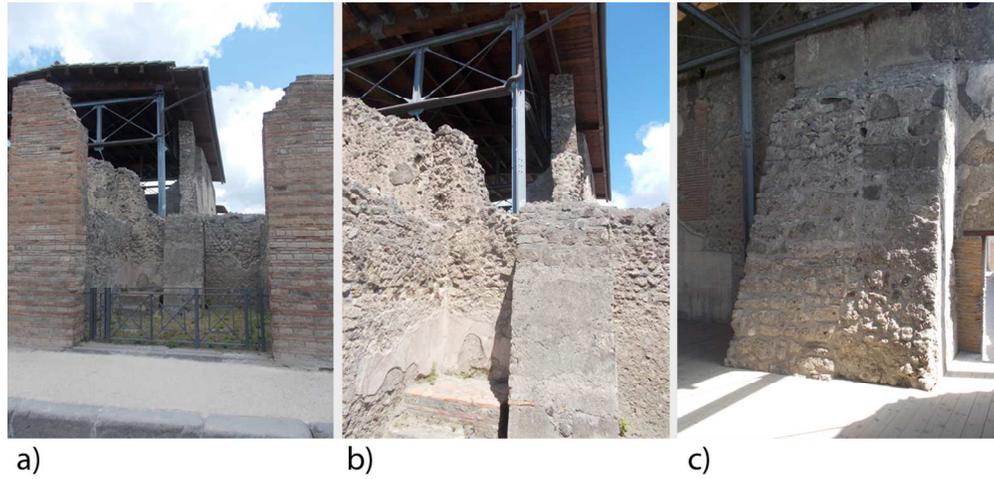
Fig. 2. a), b) Masonry buttress at the south-east corner of the destrictarium block in line with the longitudinal wall; c) masonry buttress inside the block placed in correspondence to the colonnade

Some supporting and safety works carried out on the building used as *destrictarium* and its service rooms (*nymphaeum*), such as the two buttresses built on the building peripheral walls (Fig. 1,2,3), are particularly explicative.

Specifically, the buttress near the south-east corner of the building, aligned with the wall plan facing the *palaestra* (Fig. 2), is doubtless intended to oppose to the possible collapse of masonry portions near the cantonal.

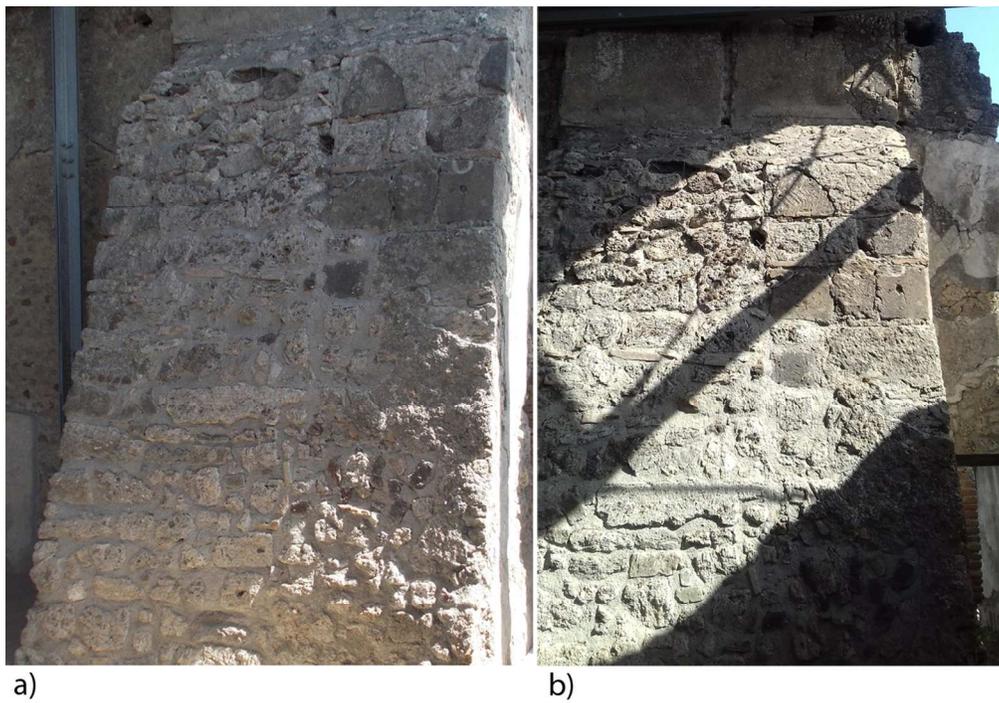
Fig. 3. a,b) Detail of the two different constructive techniques adopted to build the masonry buttress inside the dextriarium block

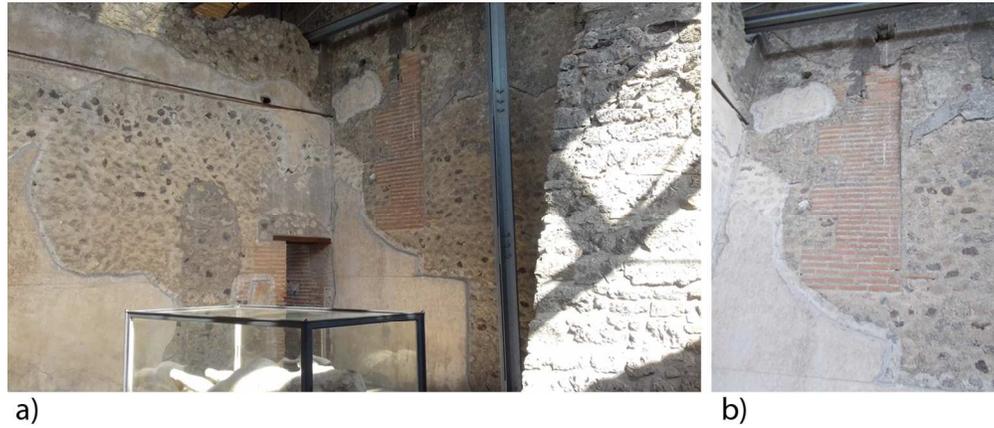
Fig. 4. Detail of the masonry arrangement of the destrictarium walls, seen from inside the block. In a) the inner wall separating the destrictarium from the nymphaeum and in b) the infill of two pre-existing windows on the east wall facing the palaestra

8
9 Therefore, the maximum rotation has involved the masonry wall portion which was directly
10 subjected to the hammering action of the peristyle colonnade and the wall above it.
11 Another crack (Fig. 11) involved that masonry wall at a distance of 1.5 meters from the
12 previous one. Even if it is clearly readable, it is a minor crack since in correspondence to it
13 the wall portion has taken advantage of the existence of the transversal inner brace wall
14 which was able to act as an intermediate restraint even if it is not linked to the wall under
15 study (Fig. 4a e 12).
16
17

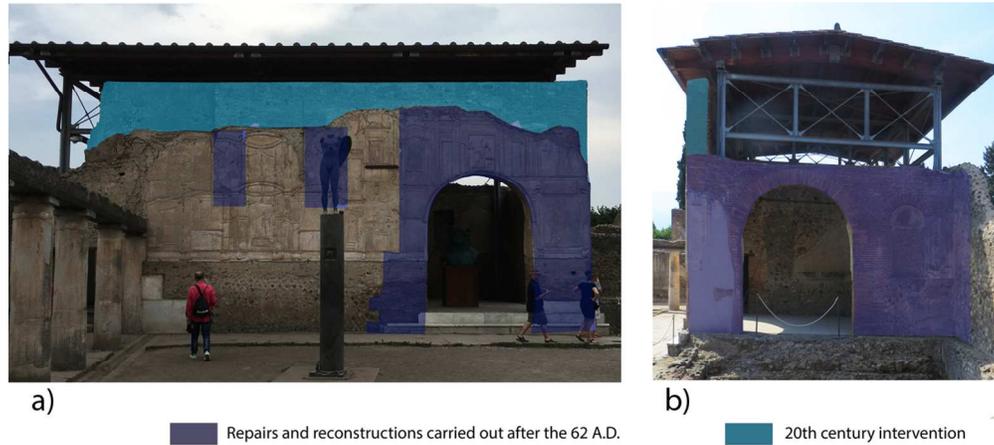
Fig. 5. Post-earthquake reconstruction interventions of some masonry wall portions collapsed and infill interventions of the windows on both the east (a) and north (b) wall of the destrictarium-nymphaeum block. The photo shows also the top of the east wall reconstruction, carried out in the mid-twentieth century

42
43 Others important clues useful for timeline assessment of the seismic events which have
44
45 damaged the building can be deduced by observing the exterior façade of the main wall
46
47 facing the *palaestra* (Fig. 5, 6 and 10). Indeed, the façade shows its surface entirely
48
49 coated by painted stucco decorations that depict Hercules, Jupiter and Apollo and
50
51 generally some mythological figures framed by fantastic architectures, dating back to the
52
53 IV style, in vogue during the 1st century, in accordance with Maiuri's assumption. This
54
55

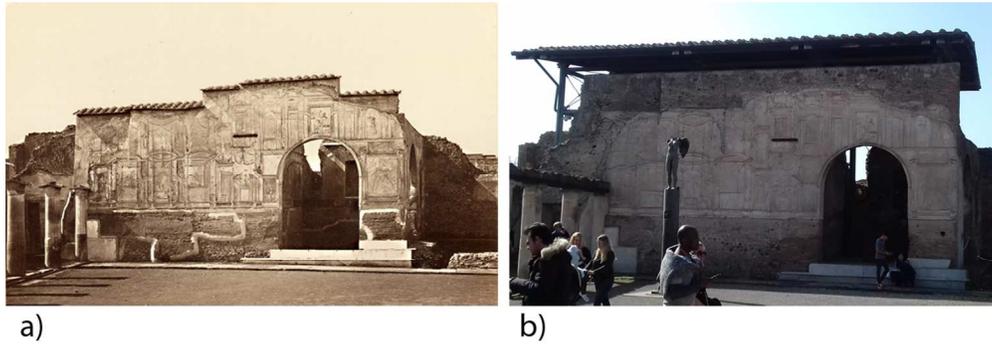
Fig. 6. Destrictarium block seen from the palaestra: a) historical photo; b) current photo (February 2017)

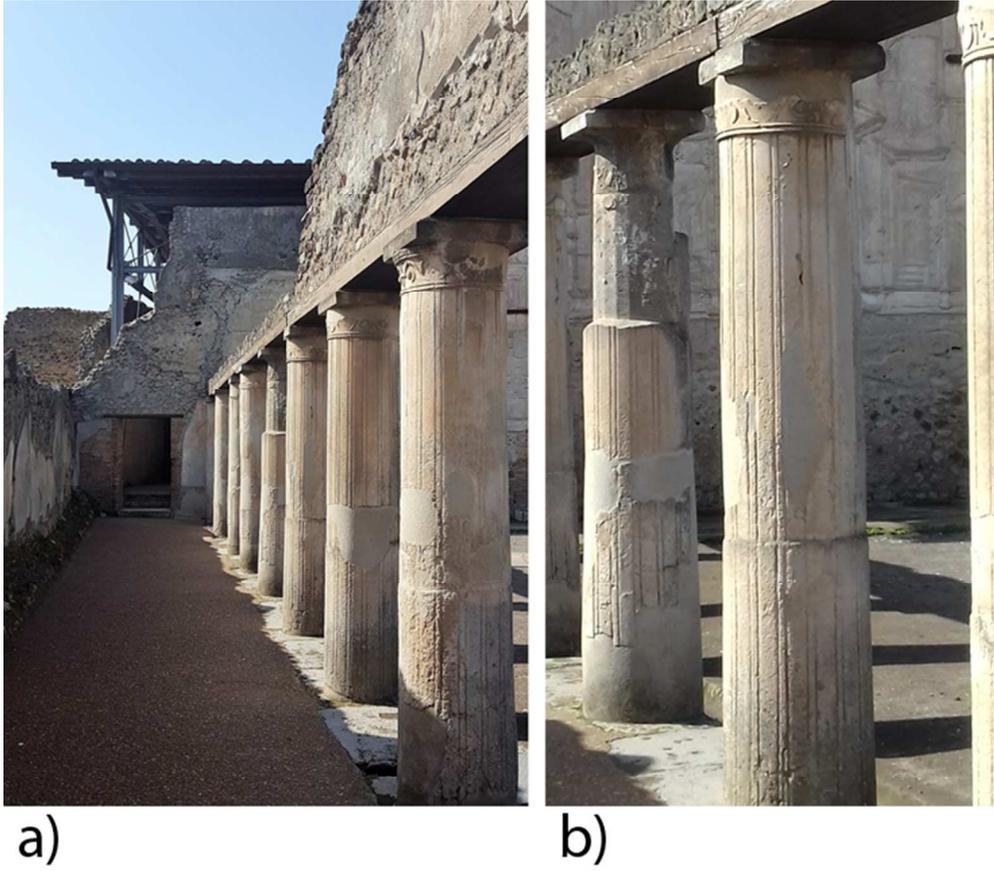
Fig. 7. a) Portico leading to the destrictarium block; b) detail of the columns which highlights the strengthening interventions based on the increase of their diameter

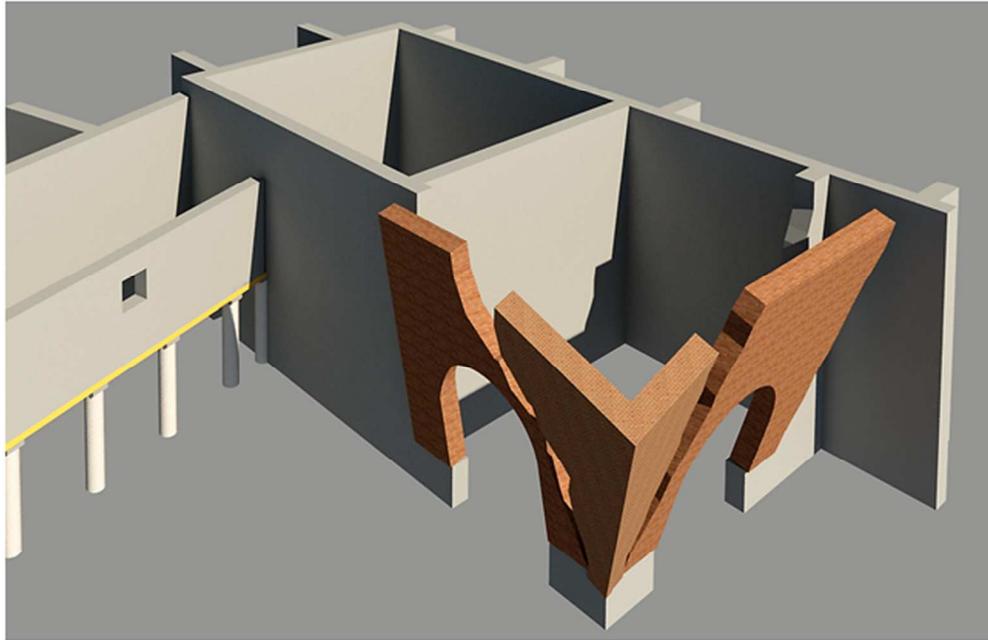
Fig. 8. Schematic representation of the collapsed nymphaeum masonry portions (north-east side) attributable to the first earthquake in AD 62

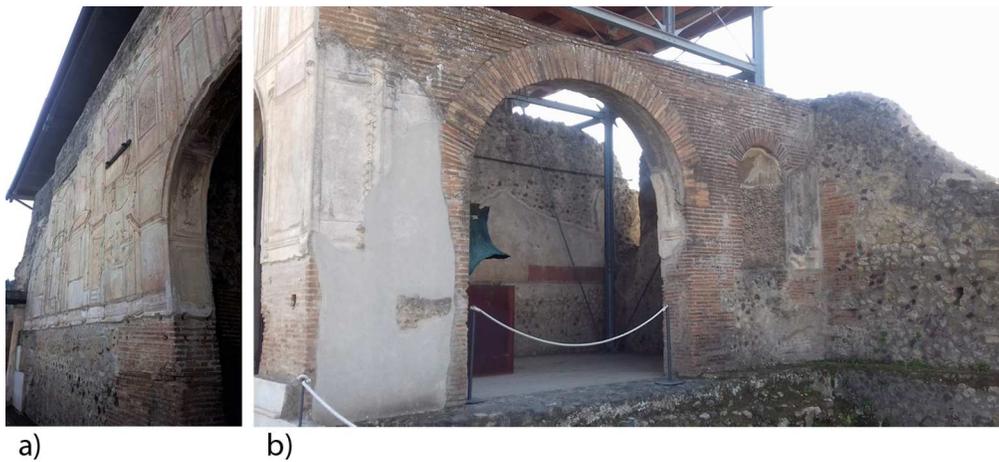
Fig. 9. The nymphaeum of the destrictarium: a) east wall facing the palaestra; b) north wall facing the swimming pool

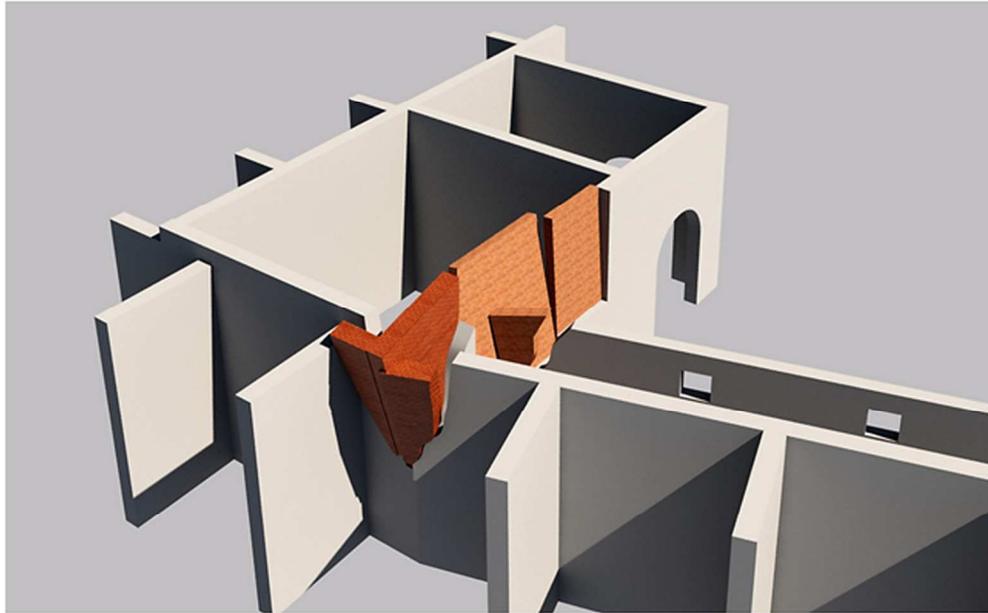
Fig. 10. Schematic representation of the collapsed destrictarium masonry portions (south-east side) attributable to a subsequent seismic event

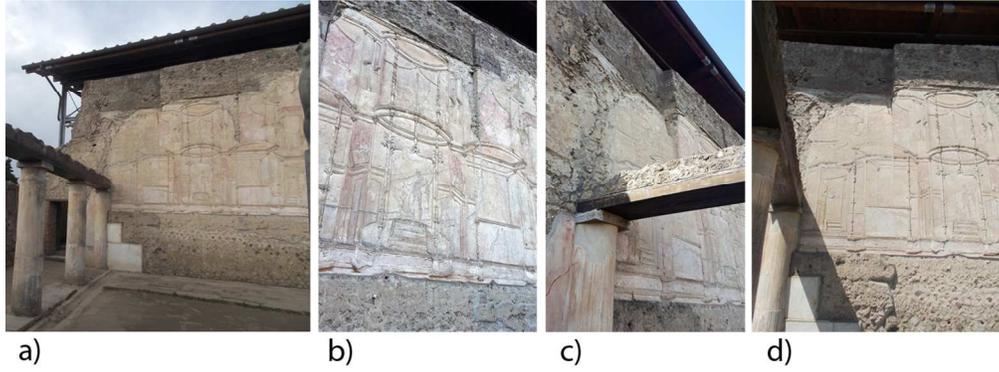
1
2
3 The resultant cracking pattern (Fig. 11) highlights a vertical crack at the height of
4 approximately 2.5 meters from the floor, which provoked a meaningful out of plumb which
5 at the top reaches the value of 35 cm.
6
7

Fig. 11. a) Cracking pattern which highlights two main vertical cracks on the destrictarium masonry wall; b) detail of the minor crack; c,d) detail of the major crack

- 43
44
45 - the overturning beginning, towards the inside of the *dstrictarium*, of a wall
46 macroblock facing the *palaestra*, between the corner and the major vertical crack
47 visible in Fig. 11, not prevented by any horizontal retaining structure since it is a
48 double-height block without an intermediate floor, as mentioned above (mechanism
49 4). It is hypothesized that the wall overturning, due to the hammering action exerted
50 by the masonry wall above the colonnade, could also have involved a portion of the
51 wall better linked to it, thus generating a retaining effect. Probably, the presence of
52
53
54
55
56
57
58
59
60

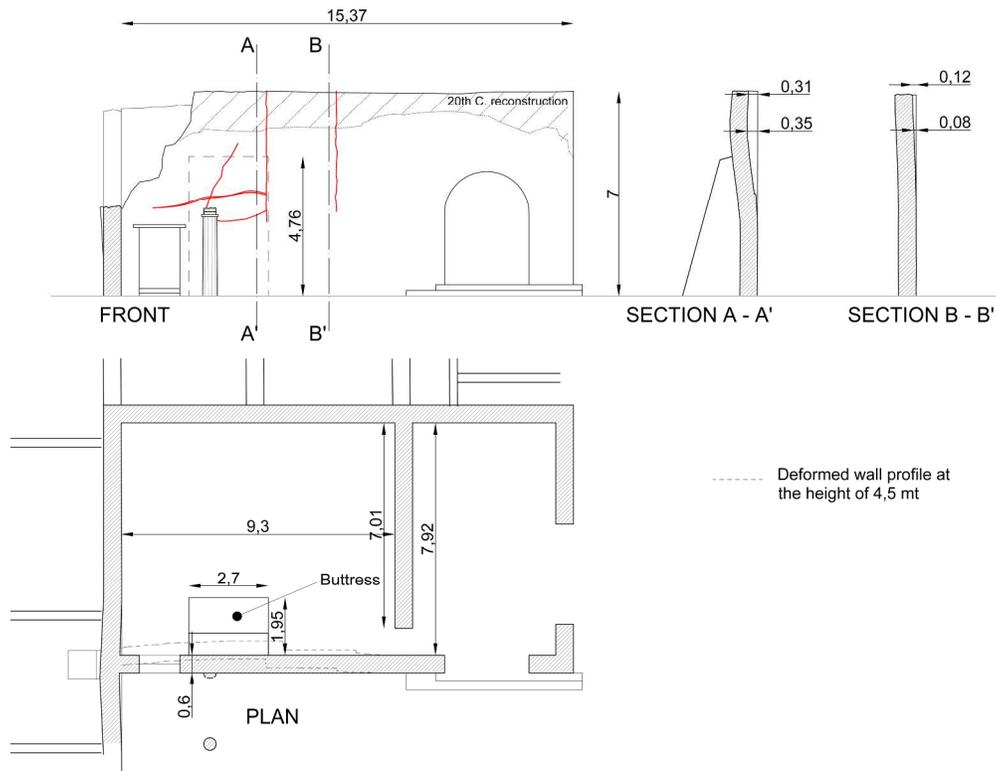
Fig. 12. The destrictarium block. Relief of the two rooms plan, elevation and cross sections of the masonry wall facing palaestra

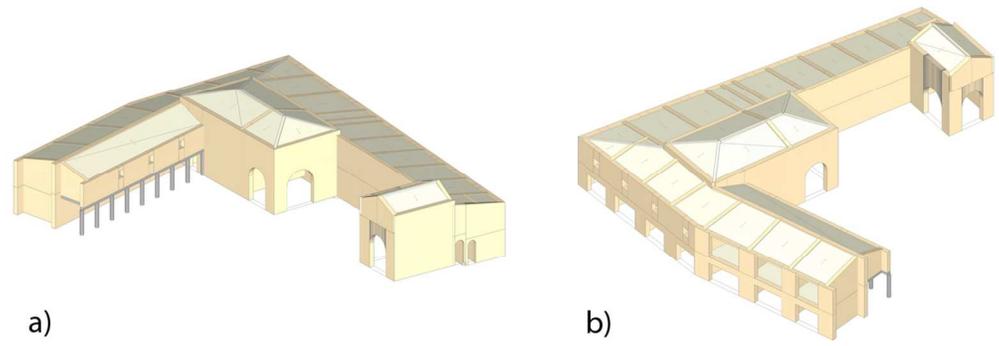
Fig. 13. Architectural model of the structural unity under study of the Stabian Baths, carried out by the software Aedes-PCM: a) view of the dextritorium and portico leading to it from inside the palaestra; b) view of the shops on the Abbondanza Street

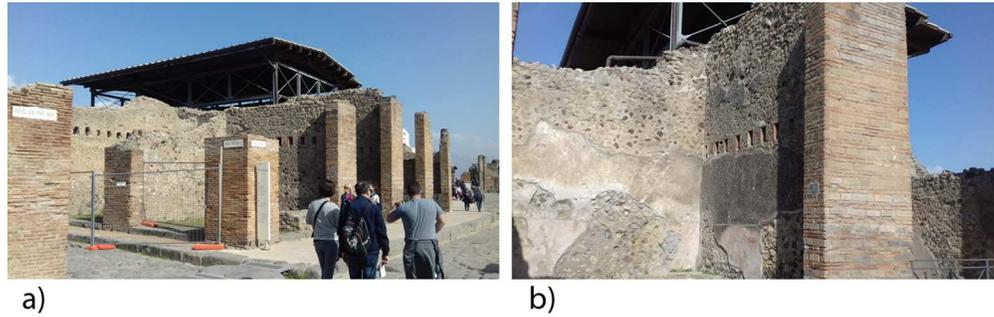
Fig. 14. a) Blocks of the shops at the corner between the Abbondanza Street and the Lupanare Alley; b) shops next to the destrictarium block and detail of the holes in the walls for the frames which supported the timber floor of the dwellings on the upper floor

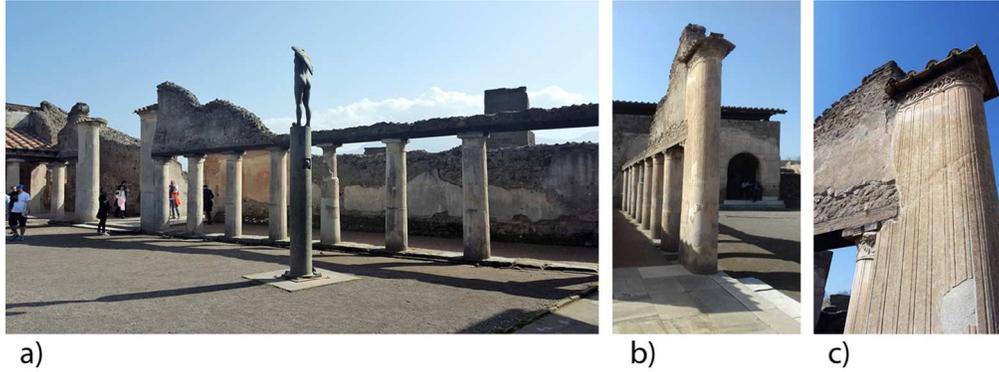
Fig. 15. Colonnade along the palaestra south side: a) overview from the palaestra courtyard; b,c) detail close to the baths entrance where remains of a continuous wall with windows above the wooden lintel of the columns is still visible

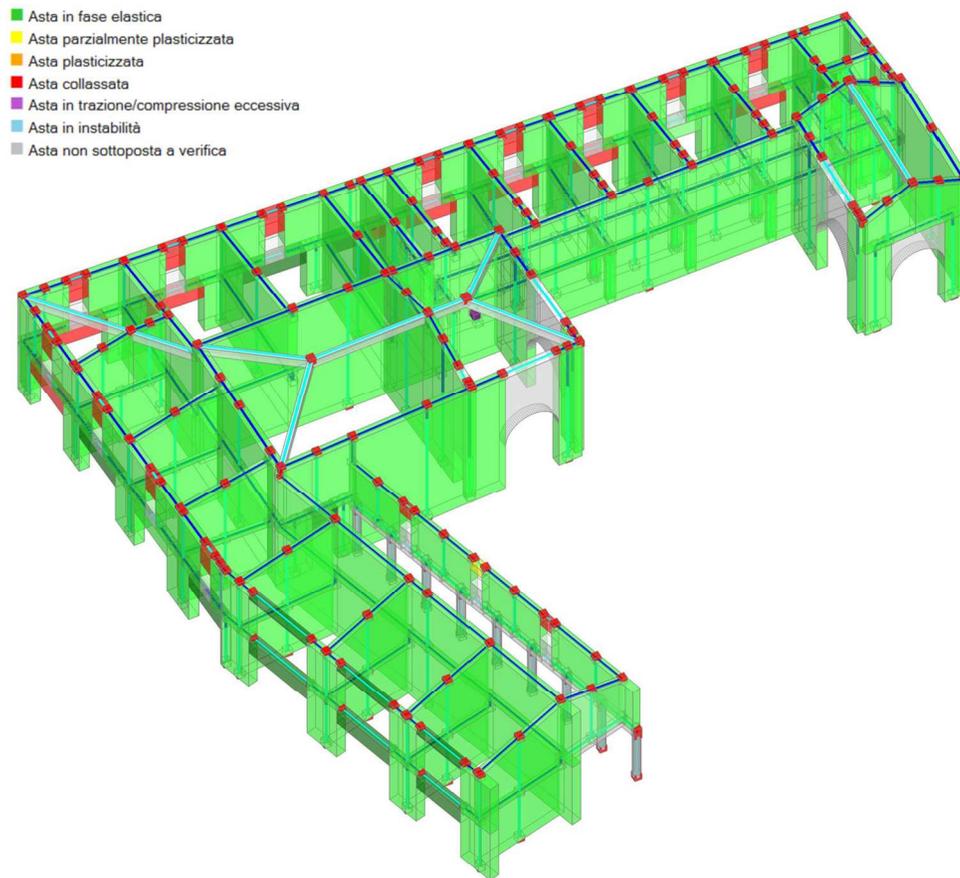
37 Fig. 16. Structural model: results of the coplanar eccentric compression force verification executed through
38 the pushover analysis (Aedes-PCM)

36 Under these interpretative assumptions of the model, the *destrictarium* building does not
37 seem to suffer damages. Indeed, except in the case in which the seismic action is
38 hypothesized in the $-Y$ direction, i.e. from west to east, in all the other cases the Ultimate
39 Limit State verification for life saving limit state (hereafter SLV) highlights a risk factor,
40 computed as the ratio between capacity and demand as a function of the Peak Ground
41 Acceleration (hereafter PGA), comprised between 1.075 and 1.089 (Table 2).
42
43
44
45
46
47
48

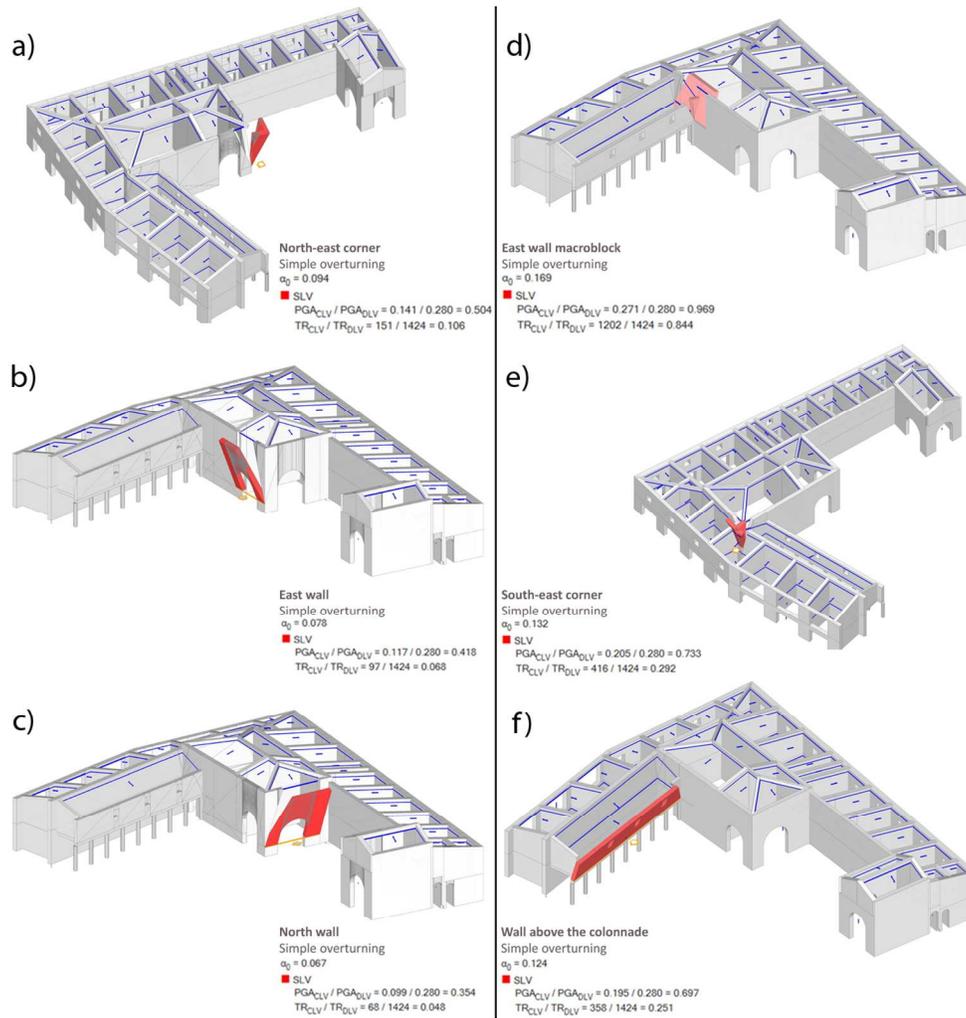
Fig. 17. Collapse mechanisms analysis (Aedes-PCM). First seismic event: a) north-east corner overturning of the nymphaeum; b) east wall overturning; c) north wall overturning. Subsequent earthquake: d) east wall macroblock overturning of the dextritorium; e) south-east corner overturning; f) wall above the colonnade overturning

10
11 For each analyzed mechanism, the seismic risk factor computed is much lower than one,
12 ranging from 0.35 to 0.73. This highlights the actual vulnerability of the masonry wall
13 portions that, in effect, collapsed during 1st century seismic events. It is worth noting that
14 only the overturning mechanism of the eastern masonry wall macroblock (mechanism 4)
15 has a risk factor prone to one (0.969). Indeed, this condition is perfectly coherent with the
16 fact that such a masonry wall portion, actually, has not completely overturned, but it has
17 displaced in an out of plumb position towards the inside of the building.
